AI-AEC-12670
METALS, CERAMICS,
AND MATERIALS

HELIUM EMBRITTLEMENT
OF
TYPE 316 STAINLESS STEEL

CONTRACT: AT(04-3)-701
ISSUED: APRIL 30, 1968

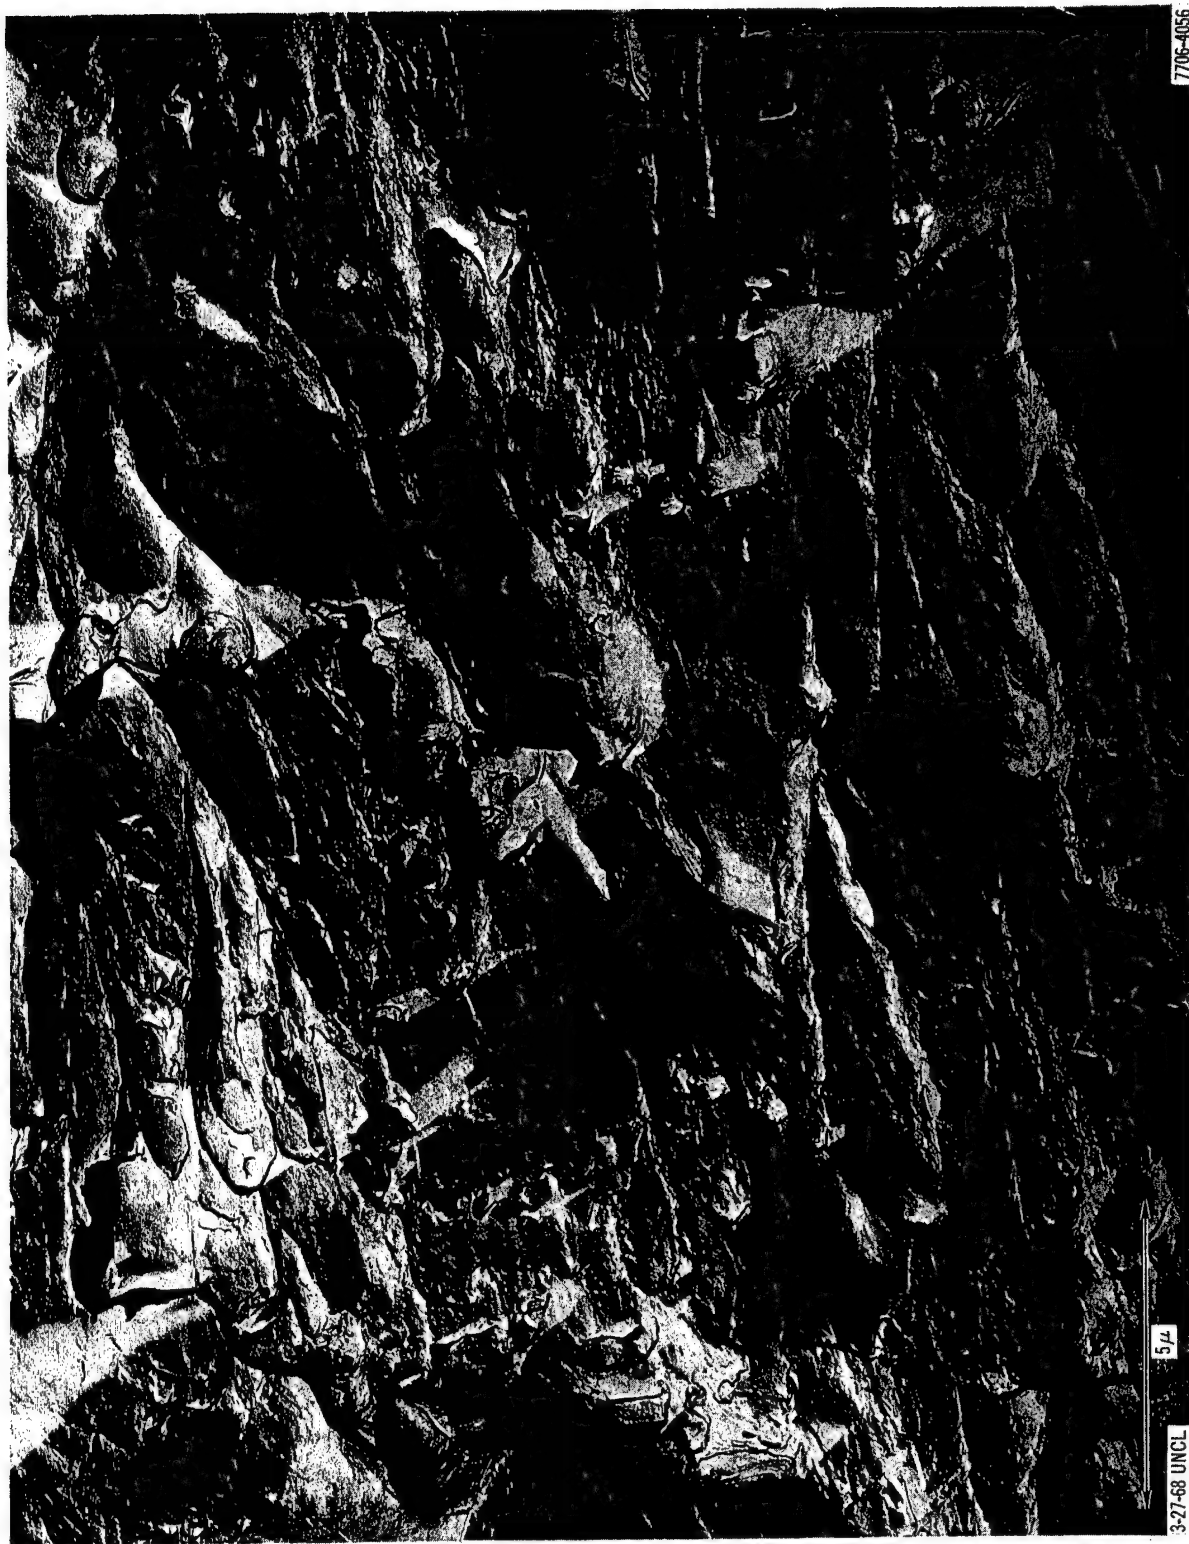
Figure 5. Fractograph of Type 316 Stainless Steel Without Helium
Tested at 540°C, Showing Shear-Rupture Dimples

At 540°C all samples given either treatment with or without He failed transgranularly. The mechanism of shear-rupture was operating as evidenced by the shear-rupture dimples in Figure 5 which typifies all fractographs of samples tested at this temperature. The mode of failure of samples given Treatment 13 with or without He, and of samples given Treatment 6 without He was transgranular at 650°C. However, samples given Treatment 6 with He showed a mixture of transgranular and intergranular failure.

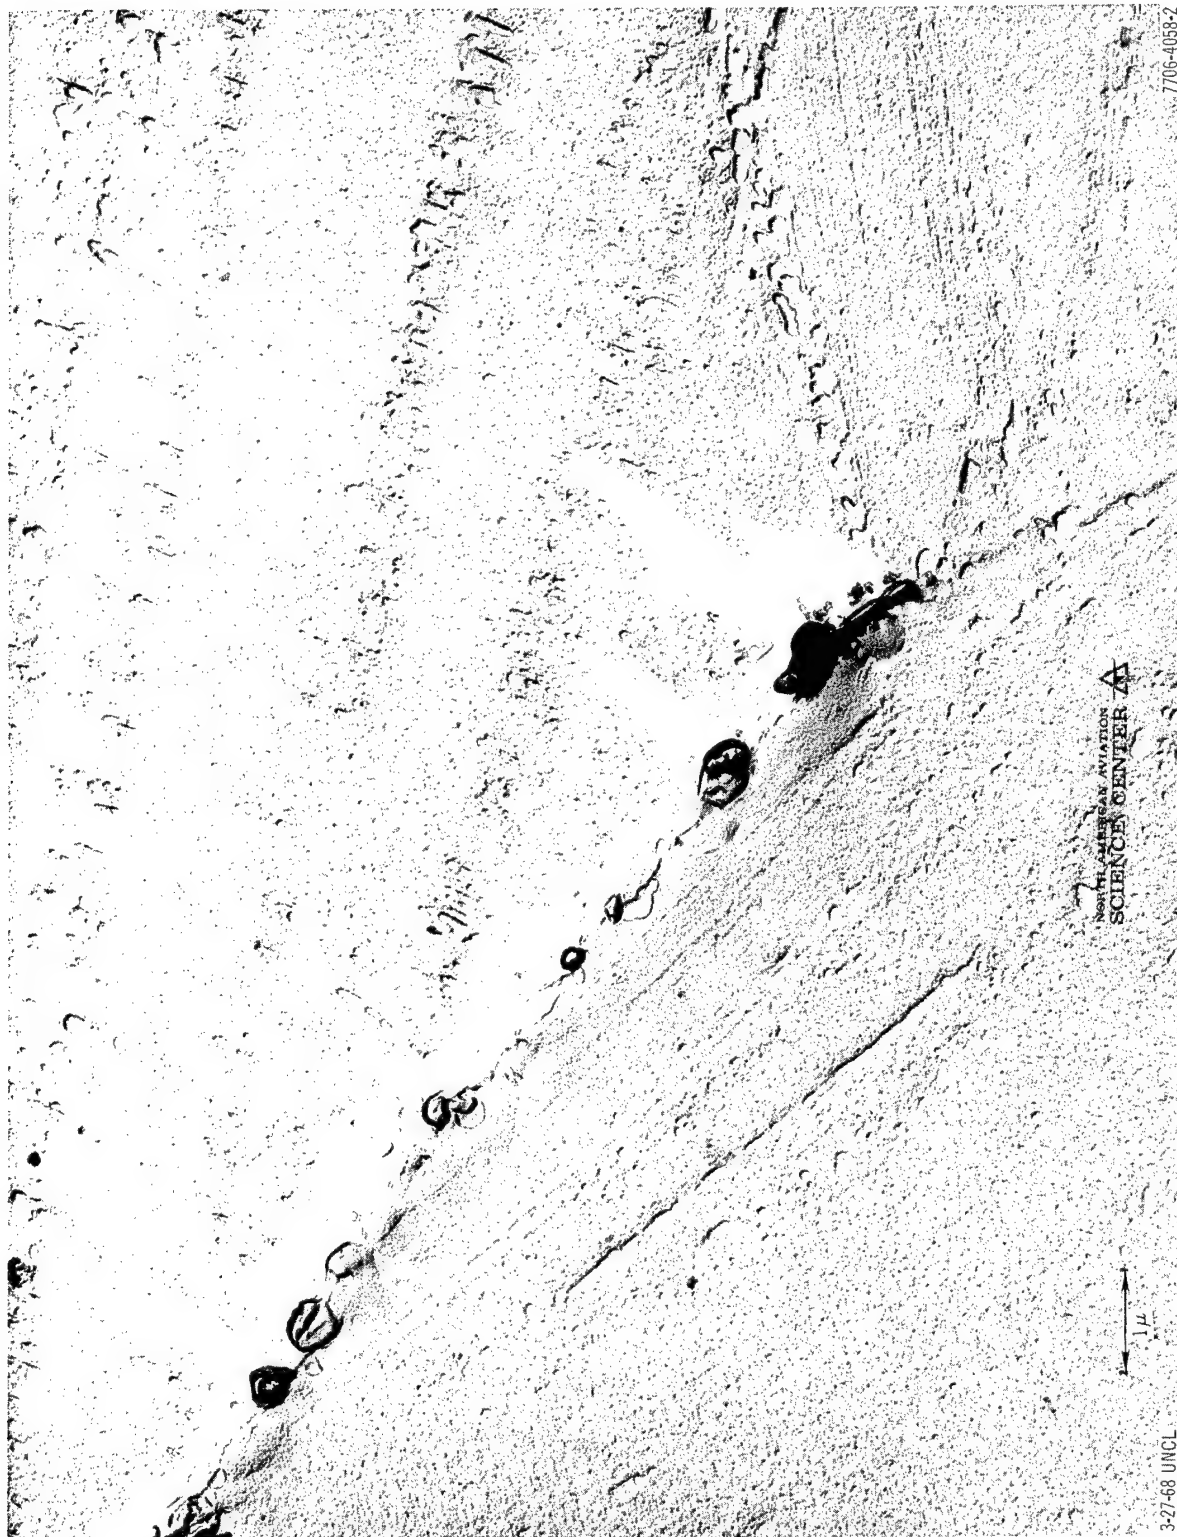
Figure 7b. Replica Electron Micrograph of Type 316 Stainless Steel
 With 4 x 10⁻⁵ Atom Fraction Helium Tested at 760°C, Showing
 Voids Adjacent to Grain-Boundary Carbides, Treatment 13

Figure 7 shows voids in samples with He tested at 760°C. They are situated on grain boundaries adjacent to carbide particles. The tensile axis is parallel to the direction of the white shadow. The relative frequency of these voids parallels that of grain-boundary cracks as stated above. The great majority of voids were associated with grain-boundary carbide particles, and even those which appear isolated on a grain boundary may be next to a carbide particle in another plane.

Loss of ductility due to helium is always accompanied by a failure that is partially or completely intergranular and by the presence of intergranular cracks along the gauge length. These cracks in their incipient state are located adjacent to grain-boundary carbide particles (Figure 7). Grain-boundary sliding, which probably occurs during testing, is obstructed by the presence of these carbide particles. In this situation voids are nucleated at the particle-matrix interface, and the mechanism has been described for a variety of alloys.⁽⁸⁻¹⁰⁾

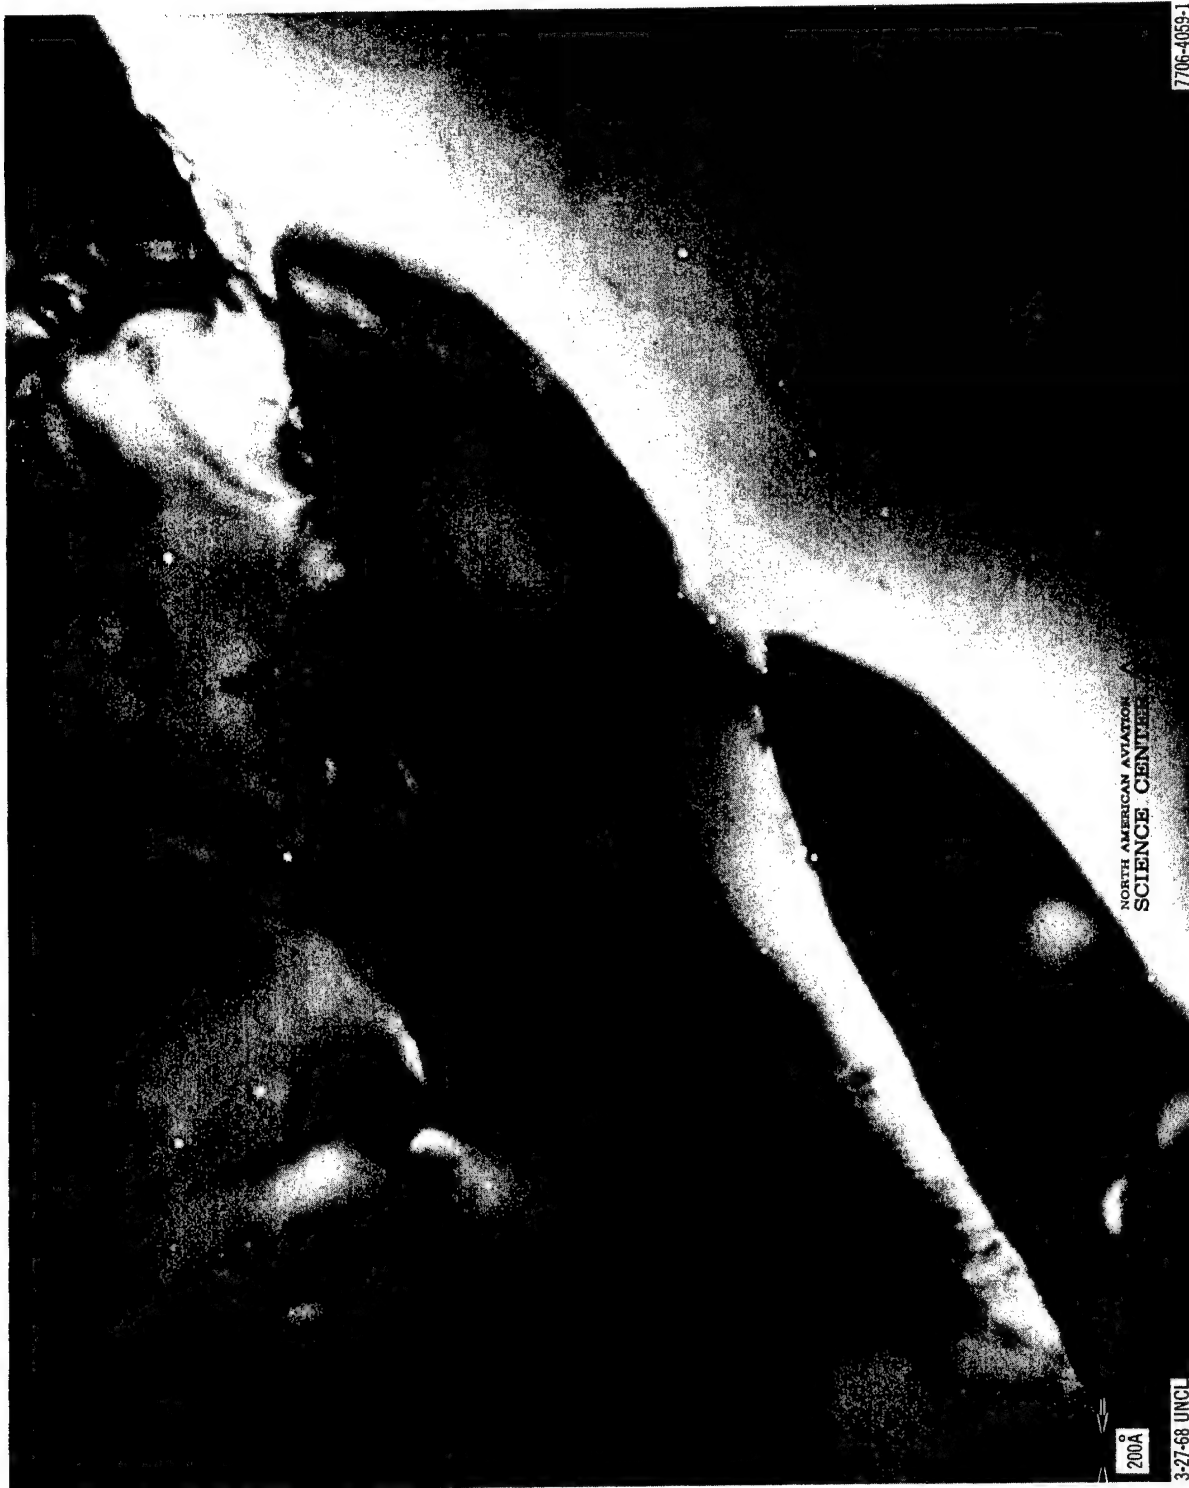
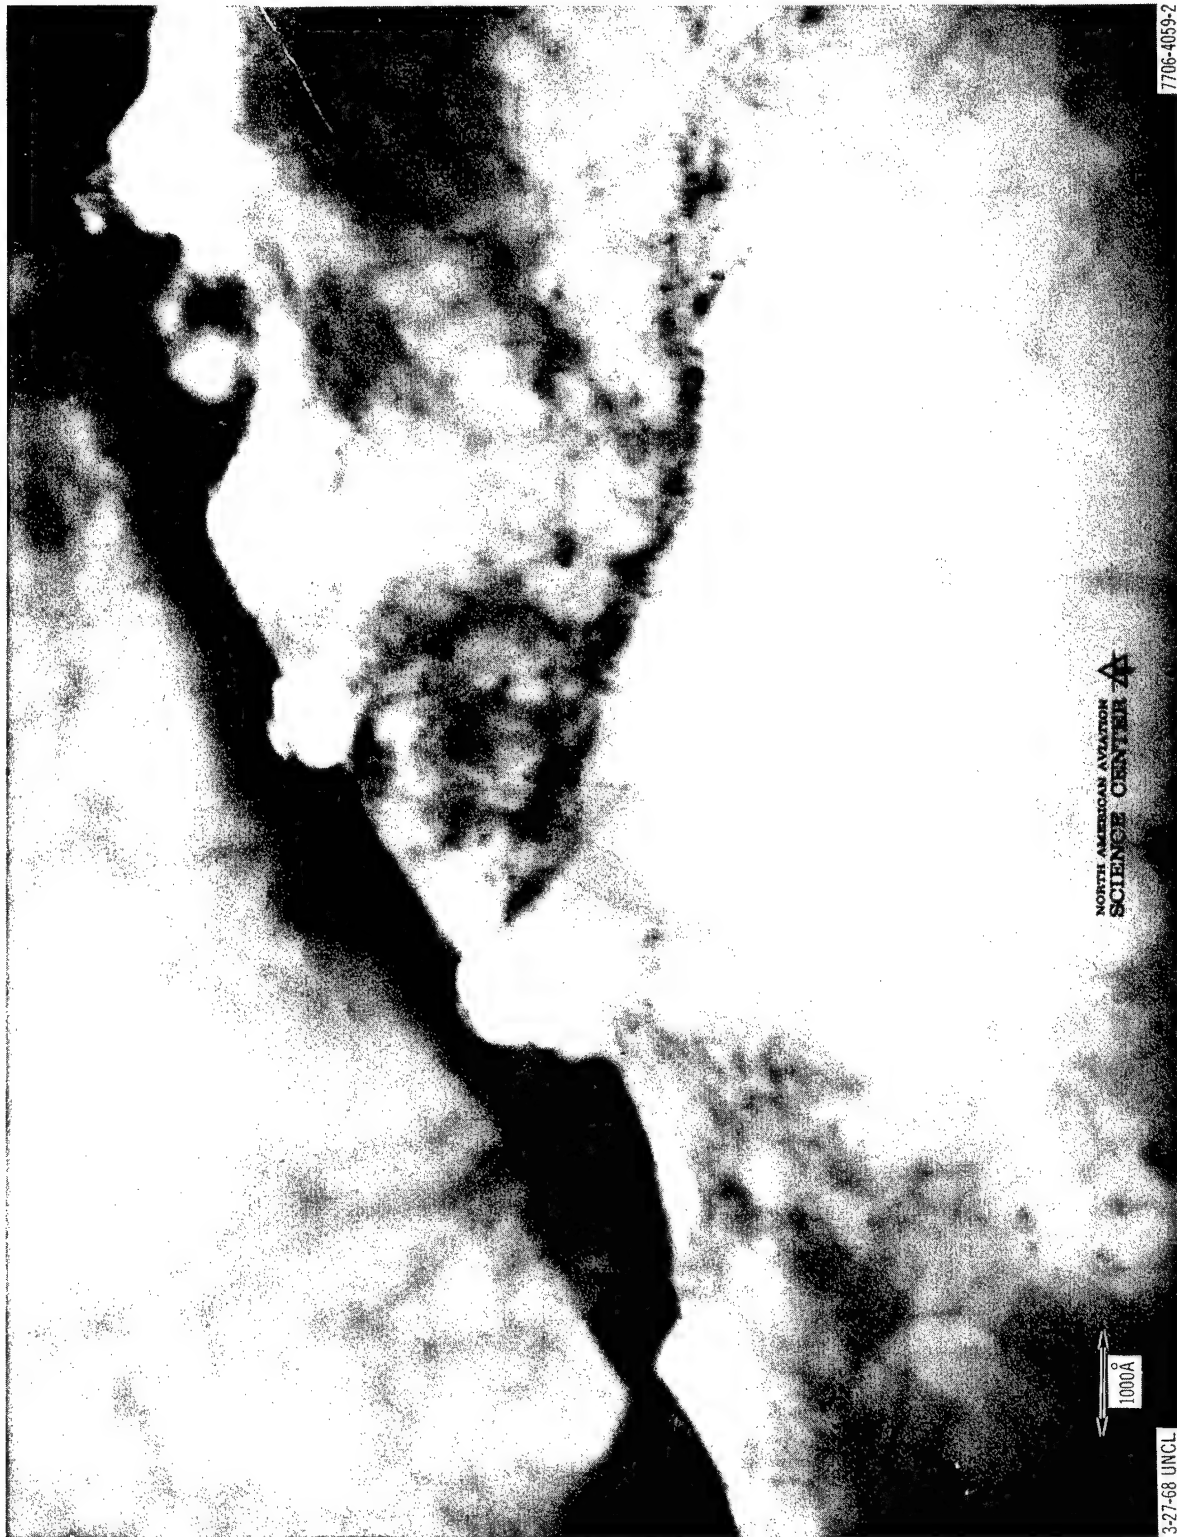
Figure 8a. Transmission Electron Micrograph Showing Helium Bubbles
in Type 316 Stainless Steel Given Treatment 6 With 4 x 10⁻⁵
Atom Fraction Helium Tested at 760°C

Figure 8b. Transmission Electron Micrograph Showing Helium Bubbles
in Type 316 Stainless Steel Given Treatment 6 With 4×10^{-5}
Atom Fraction Helium Tested at 760°C

Helium bubbles were found in samples given either treatment after testing at 760°C (bubbles were not detected after tests at 540 and 650°C) and were generally located on grain boundaries, dislocations, and precipitates. Figure 8 shows He bubbles in samples given Treatment 6. The average bubble size is less than 100 Å although some bubbles 1000 Å and greater are present on grain boundaries and attached to carbide particles (see Figure 8c).

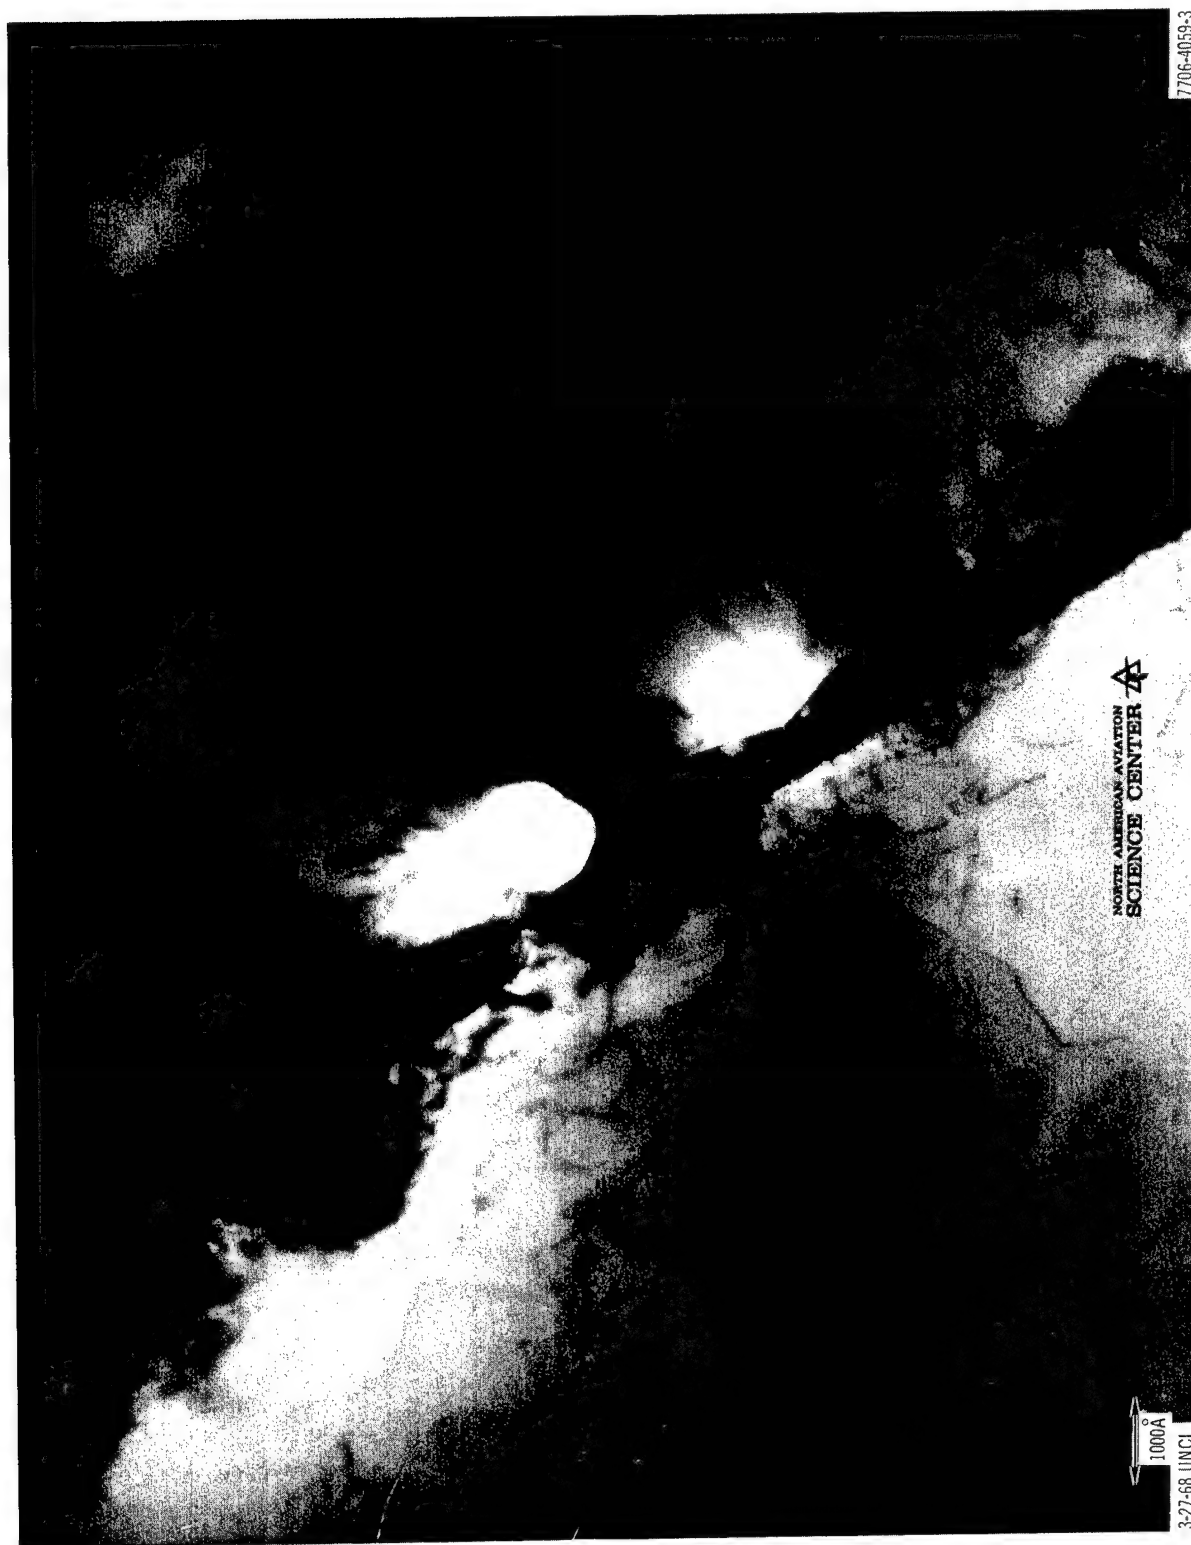
Figure 8c. Transmission Electron Micrograph Showing Helium Bubbles
in Type 316 Stainless Steel Given Treatment 6 With 4 x 10⁻⁵
Atom Fraction Helium Tested at 760°C

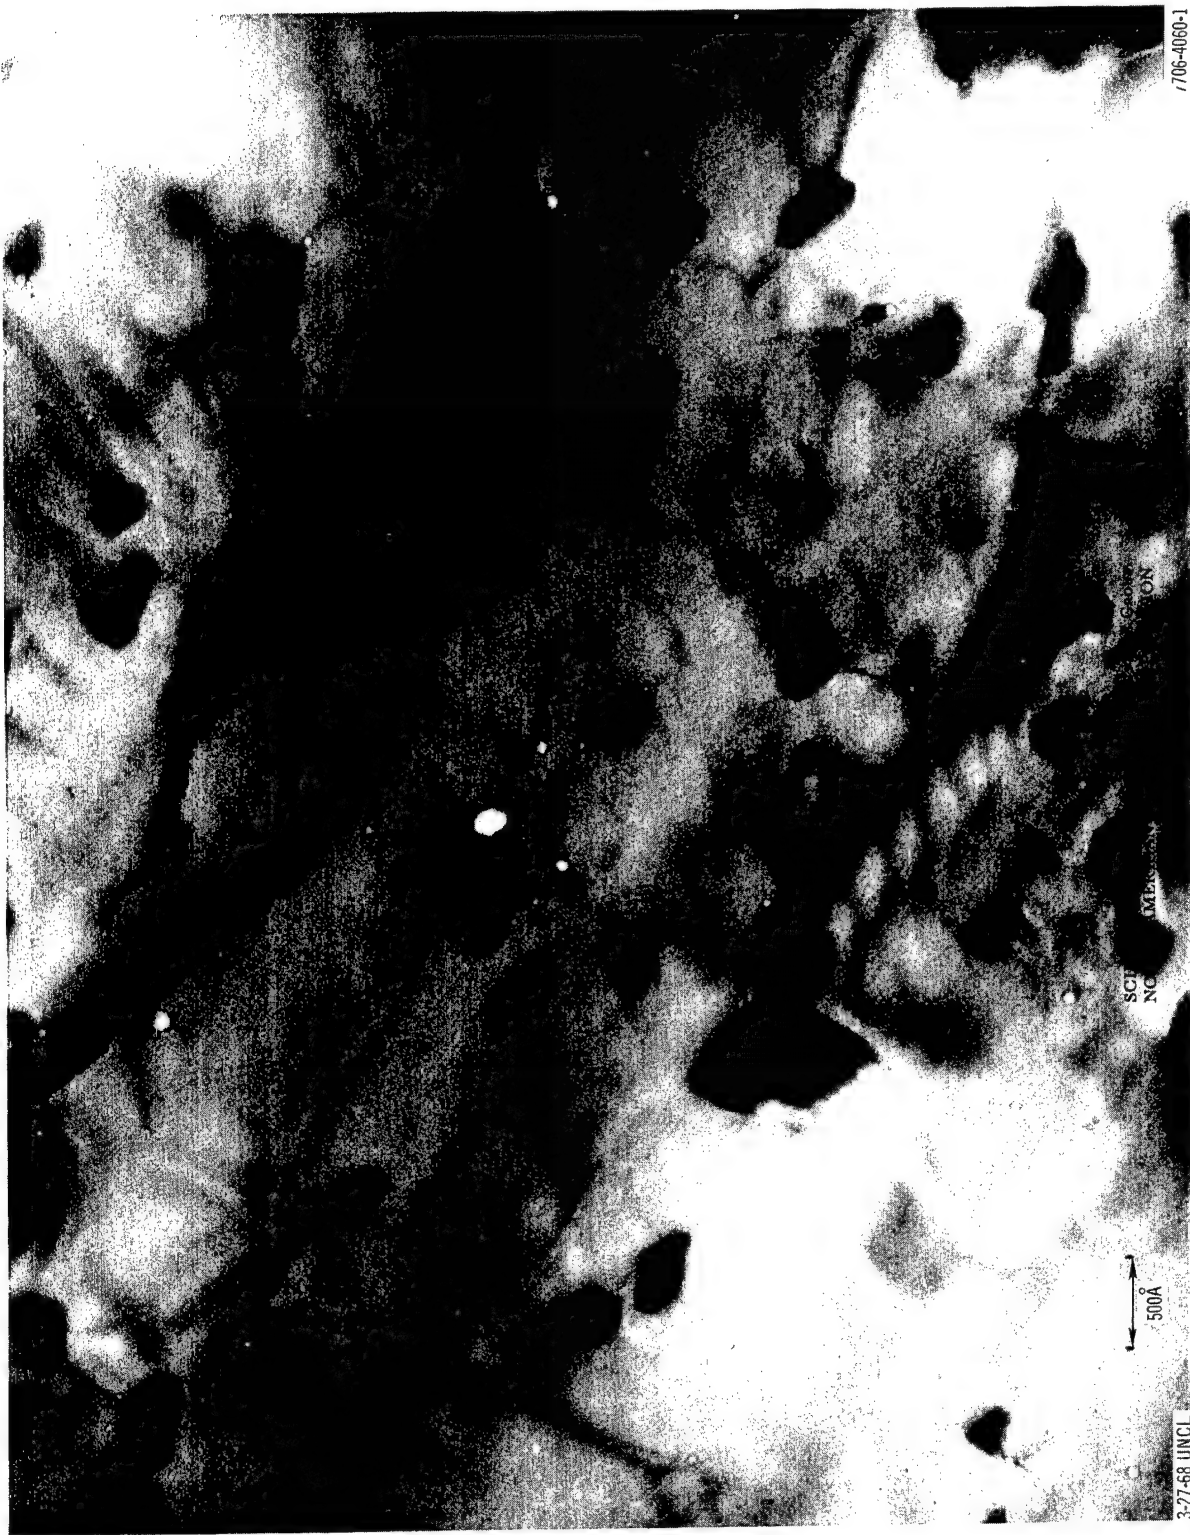
Figure 9a. Transmission Electron Micrograph Showing Helium Bubbles
in Type 316 Stainless Steel Given Treatment 13 With 4×10^{-5}
Atom Fraction Helium Tested at 760°C

Figure 9 shows He bubbles in samples given Treatment 13. Their average size is also less than 100\AA but a very large bubble ($>2000\text{\AA}$ in one dimension) has formed on a grain boundary (see Figure 9b). Most of the small bubbles are attached to σ -particles. Large bubbles were significantly less prevalent in samples of Treatment 13 than in 6.

Samples given Treatment 13 show loss of ductility beginning above 650°C, while at this temperature those given Treatment 6 have already lost more than half their ductility. This is due to the effectiveness of the high density of σ -particles (10^{13} cm^{-3}) in trapping He (seen in Figure 9a as bubbles attached to the particles), thereby delaying the accumulation of He at grain boundaries.
